NATIONAL ADVISORY COMMITTEE FOR AERONAUTICS

TECHNICAL NOTE 2157

STATIC AND IMPACT STRENGTHS OF RIVETED AND SPOT-WELDED
BEAMS OF ALCLAD 14S-T6, ALCLAD 75S-T6, AND VARIOUS
TEMPERS OF ALCLAD 24S ALUMINUM ALLOY

By H. E. Grieshaber

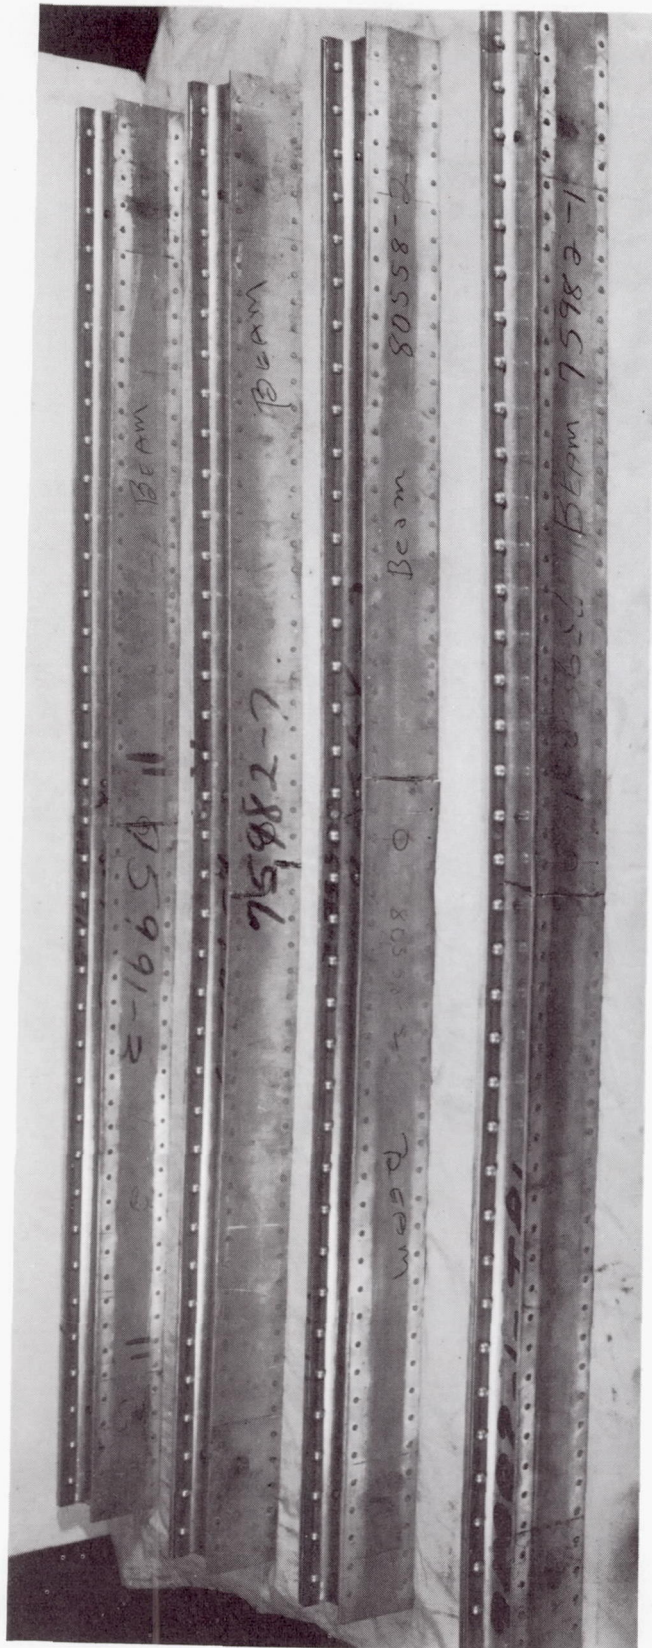
The results of the static beam tests are given in table V and in figures 6 to 10. Figure 6 shows some typical failures of riveted beams, and figure 7 some typical failures of spot-welded beams. All the failures occurred through the rivet holes or through the center of the spot welds, the failure being of the material rather than by shearing of the rivets or spot welds. The appearance of the fracture in every case was that of the shear-type failure in which the plane of the fracture is at an angle of about 45° with the plane of the sheet. It is logical, therefore, that the beams should have sustained ultimate loads commensurate with the tensile strength of the materials from which the beams were made. Failure in all the beams occurred in the region of theoretical maximum stress, at the middle of the span, that is, from rivets 26 to 30 or spot welds 18 to 20. Table VI contains the radiographic analyses of the spot welds through which failure occurred.

Figure 6.- Typical failures of riveted static beam specimens.

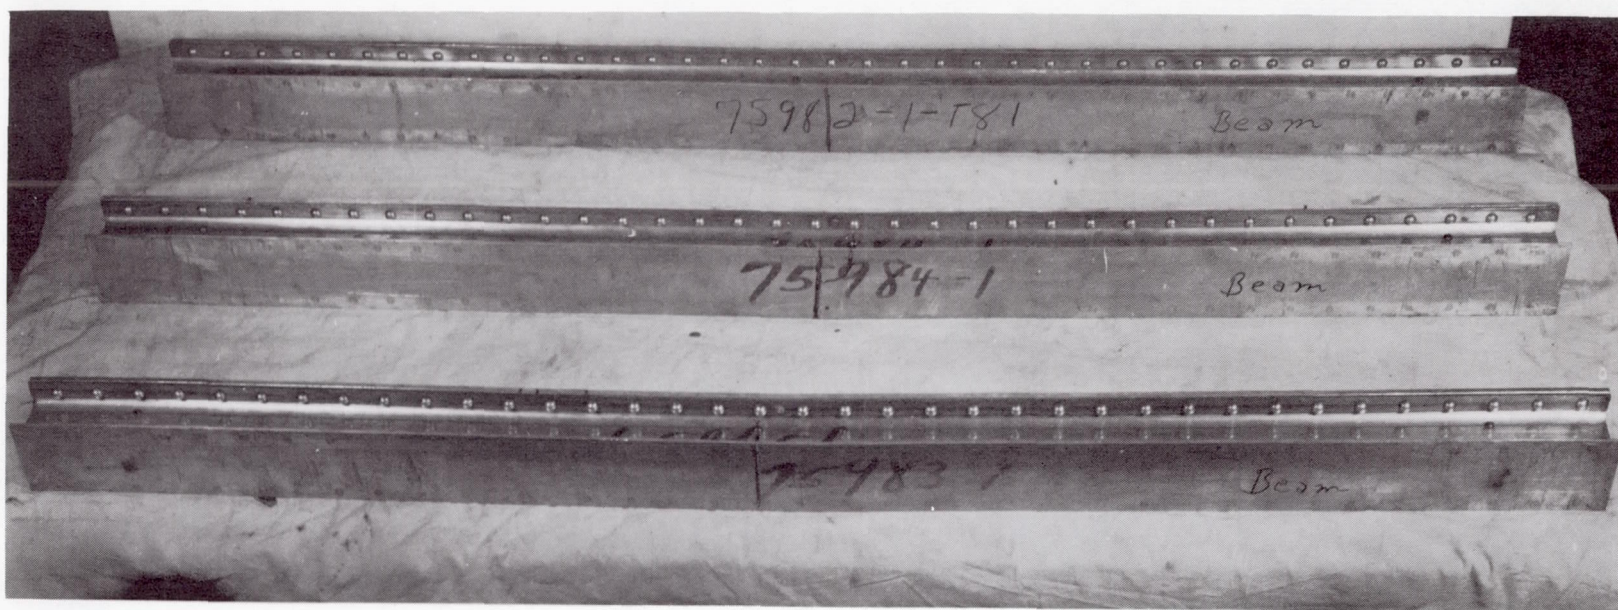
Figure 7.- Typical failures of spot-welded static beam specimens.

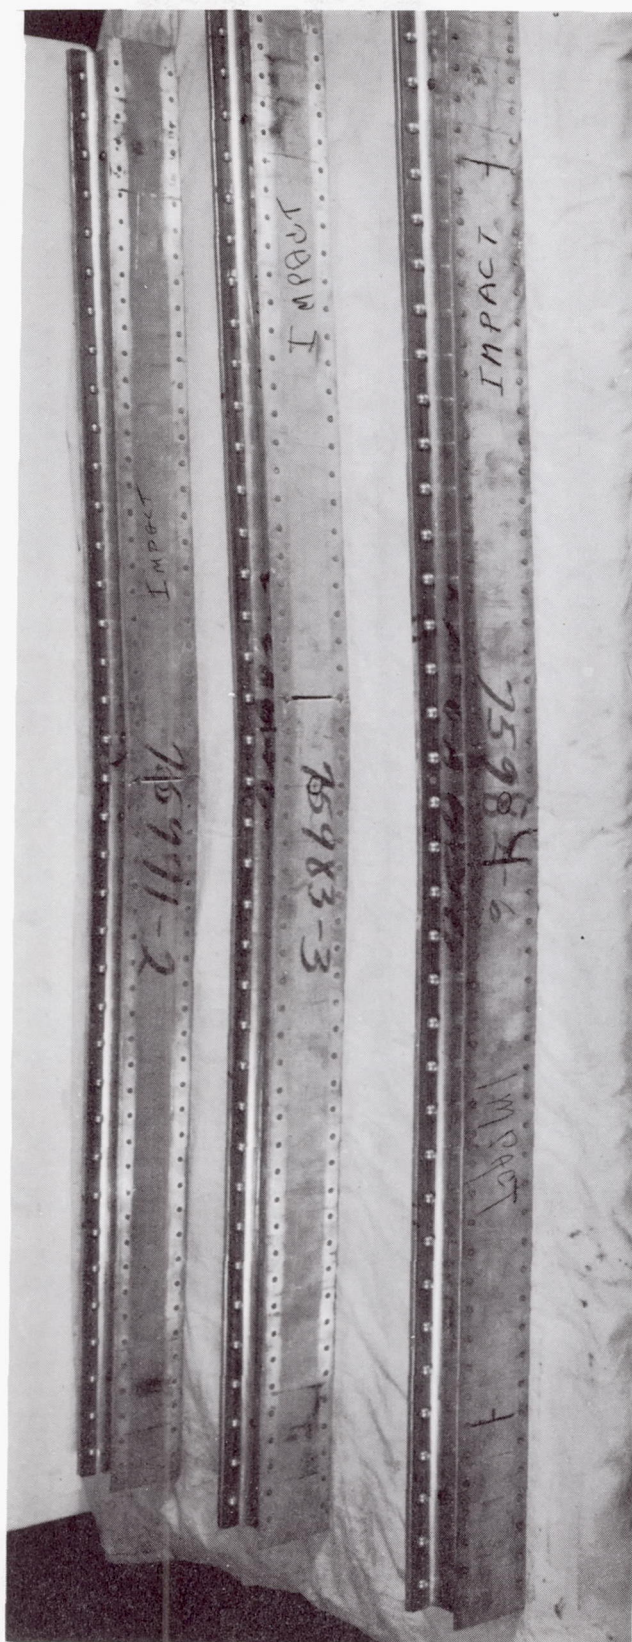
Results of the impact beam tests are shown in table V and figures 11 to 14. All the beams failed through the rivet holes or through the center of the spot welds in the same manner as in the static tests. The failures were in the sheet and not by shearing of the rivets or spots. Figure 11 shows some typical failures of the riveted beams and figure 12 of the spot-welded beams. Theoretically the region of maximum stress was from rivets 26 to 30 and spot welds 18 to 20, counting from either end of the specimen. All the beams failed either in this region or at the rivets or spots immediately adjacent.

Figure 11.- Typical failures of riveted impact beam specimens.

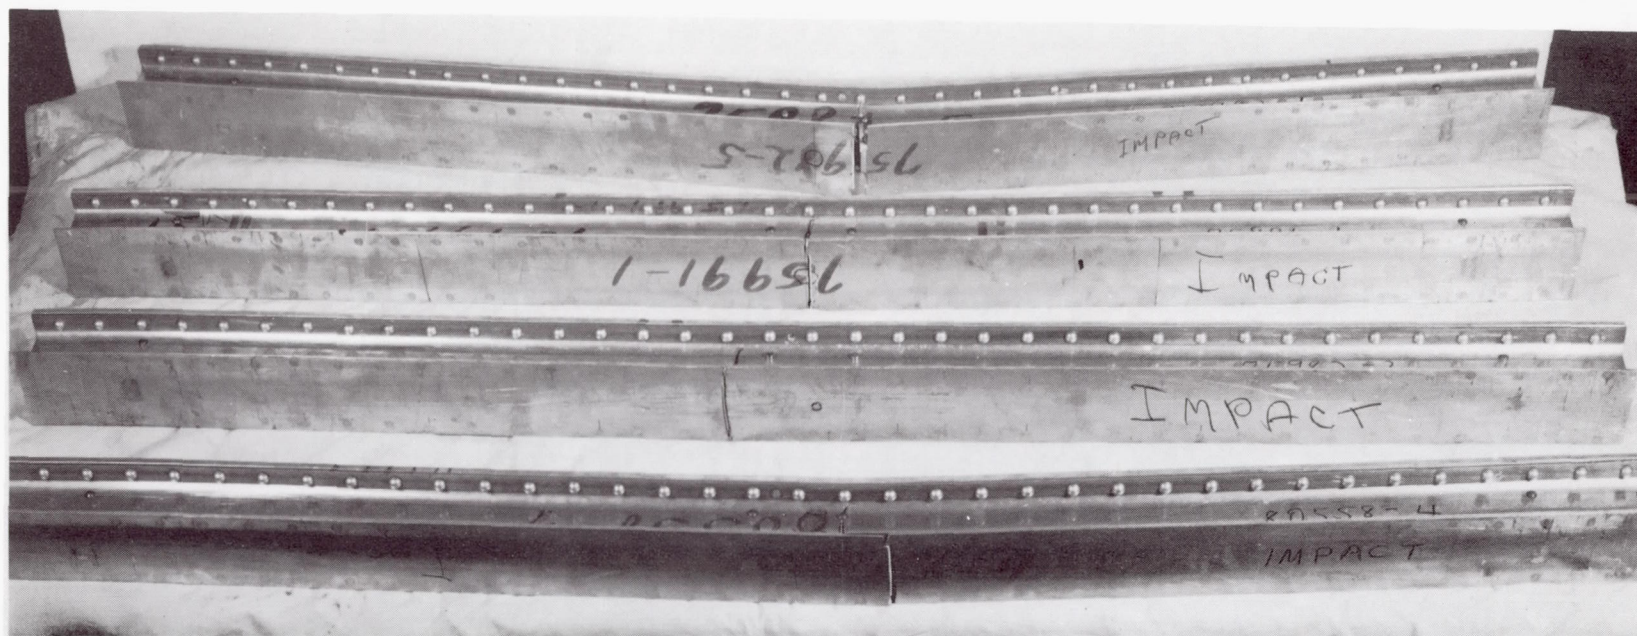
Figure 12.- Typical failures of spot-welded impact beam specimens.
